Misfire Diagnosis Case Study

Our case study concerns a 2003 Chevy pickup truck with a 6.0L engine (VIN U) and a coil-near-plug ignition system. The customer complained of a misfire and surging. Diagnostic trouble codes (DTCs) P0300, P0351 and P0357 were retrieved. All are misfire-related.

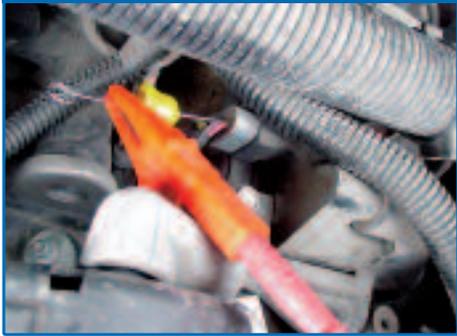
The second step in the diagnosis was to scope the #1 and #7 trigger signals with the harness connectors removed from the coil/module assemblies. This test would eliminate the coils as a possible source of excessive circuit loading. The expected voltage signal is a 0-5 volt square wave. To establish a baseline, the test was first used on the known-good cylinder coils for trigger signals. The six known-good trigger signals had a "high" voltage of 5.0 volts. Both the #1 and #7 trigger signals had a "high" voltage of only 4.75 volts.

A backprobe allows you to tap into the wiring between the PCM and the coil, without causing damage. Brace the alligator clip to avoid accidental shorts.

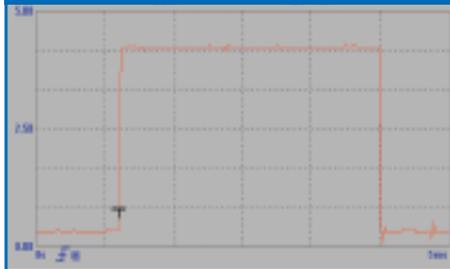
trigger signals were still 0.25 volt lower than the known-good trigger signals. Either something else in the circuit was loading down these two trigger signals or there was a PCM issue. Since the PCM was already replaced, chances were good there was something else in the circuit causing the problem.

This screen capture reveals a normal square wave control signal from the PCM to the coil primary. Our defective signal was only .25 volt below normal.
