Fine Tuning

We are going to do something a little different this time in the **Fine Tuning** department. We ran into a diagnostic case study you might be interested in. It involved a 2001 Chevrolet Impala with about 40,000 miles on it. The A/C fan and cruise control would intermittently stop working while the customer was driving. There seemed to be no rhyme or reason to the failure. The vehicle could be driven for days before the problem would occur.

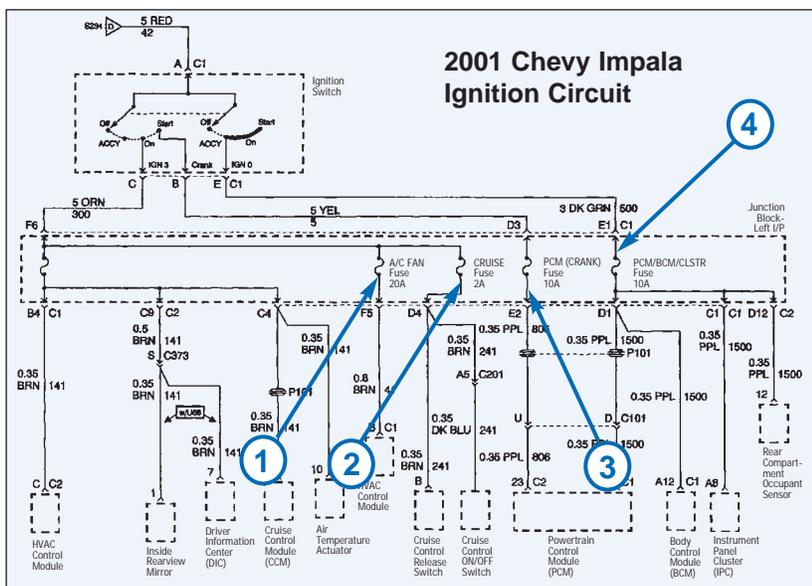
These were the same steps we took. Darn, no TSBs were found. We then took a close look at the wiring diagram (a simplified version is shown here). Notice the A/C fan and cruise control are fed from the same ignition switch terminal. This was the first real clue. Could the ignition switch be at fault? Possible, but to be sure we still need to get the problem to occur. The ignition switch is in the dash on this vehicle, which makes access difficult. It's not a five minute steering column ignition switch replacement.

Before a road test, let's take a little closer look at the wiring diagram. Notice the A/C fan and cruise control are both fused. If both of these circuits are failing at the same time, they are probably losing current at the same time too.

We decided to backprobe the fuse leading to the A/C fan. Notice the ignition switch is fed by a single wire. Could this wire be losing current, knocking out the circuit and the customer just doesn't notice the other failures? At marker #4, you will see the PCM/BCM cluster fuse which is fed by a different terminal of the ignition switch. We also backprobed there.

We grabbed two DVOMs and went on a road test. After about twenty minutes of driving around, the fan went out and the cruise control quit. We connected the meters - one to each backprobe - and there it was. Backprobe #1 read 2.23 volts and #4 read 12.25 volts. Based on this information, we can be reasonably certain that the ignition switch is defective.
