Jeep Ignition Sync Problems

This issue's case study was contributed by Jerry Truglia.

Our problem vehicle is a 2000 Jeep Cherokee with an automatic transmission and 4.0L engine. The engine is hard to start and occasionally will not start at all. The basics, including battery, vacuum, spark and timing, have already been checked by another shop. A number of "known good" parts from an identical vehicle have also been substituted, with no improvement.

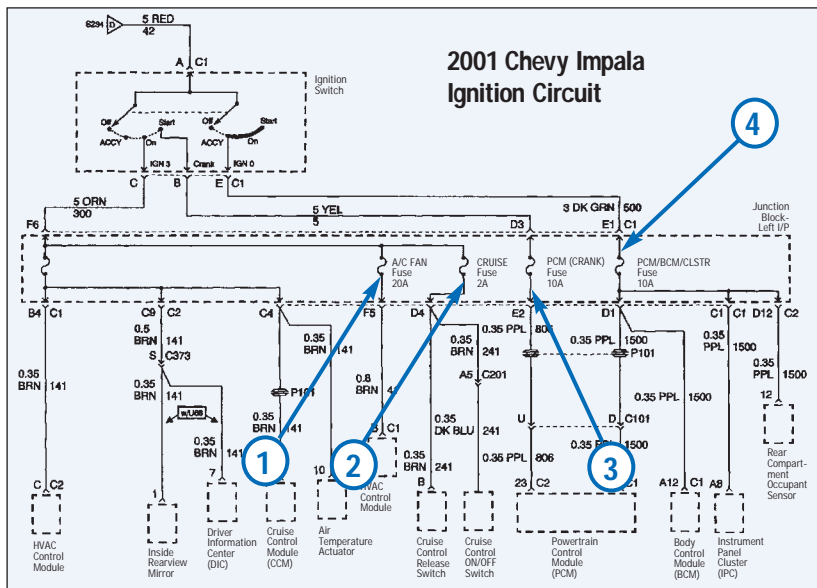
Refer to the wiring schematic at the bottom of this page. We can perform a voltage drop test across this circuit by connecting our meter to connections 1 or 2 and 4 in the fuse panel. The meter read 10.16 volts when the problem occurred, indicating a huge voltage drop across this circuit and proving the ignition switch was

defective. A fifth page with pictures of this test has been added to the PDF version of the Summer *Counter Point*. It's available for download at our website (www.airtexproducts.com).

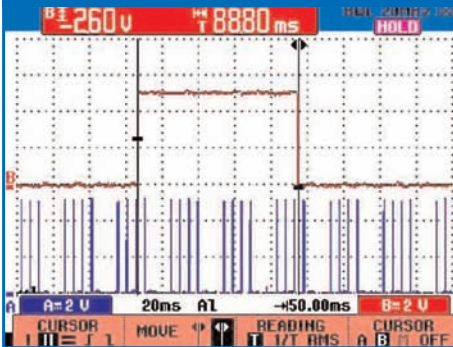
Figure 2: Bad cam and crank sensor SYNC waveforms.

Look carefully at the Jeep's crank and cam sensor waveforms in Figure 2's bad screen capture. Channel A in blue is the crank signal and Channel B in red is the cam sensor. Notice the vertical cursor lines, which make it easier to check for sync. This Jeep was way out of sync, as you can see by comparing the bad screen capture to the good screen capture in Figure 3. It's easy to know what's bad if you know what's good, which is why it's important to build a library of known-good waveforms and keep them handy for later reference. I call this comparison method *color form technology*. The explanation of what's wrong with Figure 2 follows.

When it is properly in sync, the cam sensor signal must begin and end in the gap between the three groups of four crank sensor pulses. You will notice in the bad screen capture that the cam sensor signal does not bracket the group of crank sensor signals as it should. Instead, it begins and ends during the crank

sensor signal groups. Look at the difference in the crank signal's three groups of four pulses in relationship to the cam signal in the good screen capture. It's noticeable that the group of crank sensor signals fits right into the cam sensor signal's rise and fall. However you chose to view it, the difference is clear. Remember, the scan tool PID reported that the system was in sync at the same time that I collected the bad screen capture.

This out of sync condition occurs when the oil pump drive shaft binds inside the oil pump drive housing, causing the entire housing to rotate slightly. The cam position sensor is located at the top of the oil pump drive housing, where the old distributor, cap and rotor used to be located. In extreme cases, the oil pump drive shaft or its camshaft mating gears may break, causing a no-start condition. More commonly, the housing rotates slightly, causing the out of sync condition seen here. If the housing does not appear to be parallel with the block or shows other signs of movement, the fix is to install a new housing that's been properly prelubed.

Refer to a computer-based repair information system or a printed repair manual for the proper cam sensor setup and installation procedure. Use a drill bit to line up and set the cam sensor. The hole in the shaft needs to be aligned with the hole in the cam vane blade. After installing the new parts, check the sync with your scope to verify the repair. The older engines used a similar setup. However, this newer style ignition system uses a Hall effect crank sensor—not an AC-generating crank sensor.

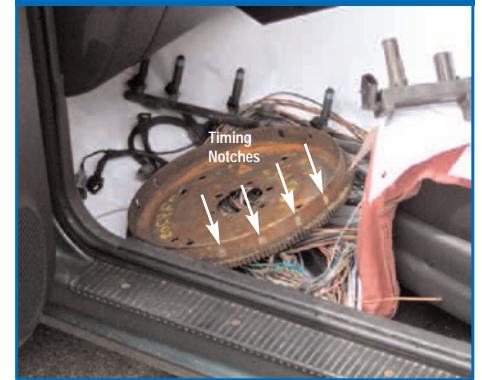
Figure 4: Flywheel/flexplate showing timing notches.

This engine uses a flex plate/flywheel that has three groups of four notches arranged around its outer circumference to determine piston position (refer to the arrows in the flex plate/flywheel photo in Figure 4). These notches are read by the crank sensor as they pass beneath it. The trailing edge of the fourth notch in each group occurs four degrees before top dead center (TDC) of the corresponding piston.

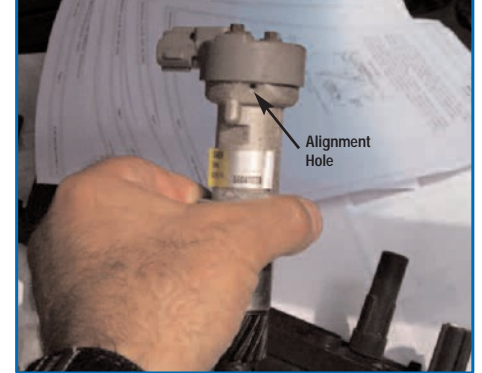
Figure 5: Cam position sensor atop oil pump drive housing. Arrow points to alignment hole.
