Evaporative Emissions Systems Part Two

Evaporative Emissions Systems - Pt. Two

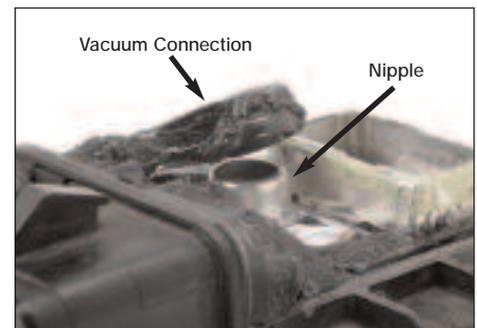
When any type of backpressure built up in the system, the vacuum connection inside the MAP sensor would blow apart. The backpressure could have been caused by a backfire, a restricted exhaust or something else. A damaged OE MAP sensor is shown in *Figure 1*.

After the MAP sensor was damaged, it could no longer report the manifold pressure reading to the PCM. Under these conditions, the PCM would respond to the absence of any vacuum signal by commanding the injectors to supply enough fuel for wide open throttle (WOT). The engine couldn't possibly burn the oversupply of fuel, causing the heavy black exhaust.

Figure 1 The vacuum connection on this OE MAP sensor has broken and separated due to abnormal backpressure.

To overcome the shortcomings of the original design, Airtex Engine Management updated the circuitry to incorporate faster, more intelligent chips. The pressure sensor is also adhered to the vacuum connection, eliminating the trend failure of the original design. Airtex Engine Management MAP sensor is shown in *Figure 2*.
