# Fine Tuning

## The Triangle Of Doom

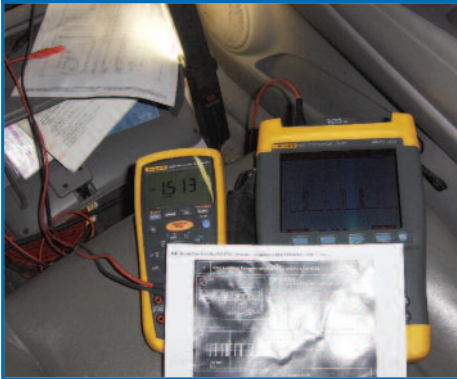
Figure 1: Checking voltage between HTE+ and HTE-

Following the Toyota flowchart and checking voltage between HTE + and HTE - of the ECM, I came up with a reading of 1.49 volts and a waveform that matched Toyota's example (Figure 1). The Toyota flowchart then states that the ECM should be replaced. I've been around awhile, and it's hard for me to swallow replacing an ECM without first checking every sensor and component that is associated with it. I think that flowcharts should be renamed "trouble charts" because in many cases that's what you will find yourself in.

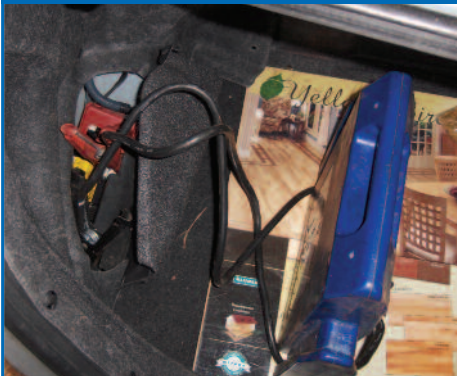
Figure 2: Installing battery pack on AGM battery

Since the flowchart did not make sense to me, I decided to get back to the basics and test the 12-volt battery. I found that the vehicle's absorbed glass mat (AGM) 12-volt battery was below specification. A word of caution is in order concerning this battery. Be careful when charging the AGM 12-volt battery because it can and will be damaged if the charging current surpasses 3.5 amps.

As you can see in Figure 2, I installed a battery pack and retested the ECM just to

verify I was testing with the correct voltage. While retesting, I captured the identical meter and scope readings, with one difference: the DTC P1636 was gone.

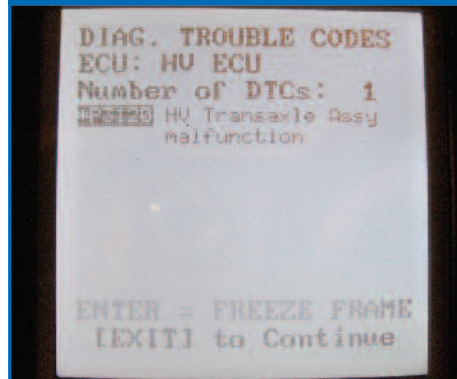
Figure 3: DTC P3120 HV Transaxle Assy Malfunction

DTC P3002 (HV Serial Communication Abnormality) deals with a communication problem to the HV ECU. This DTC was coming back even with the 12-volt AGM battery fully charged. I knew this vehicle now had a hard problem in the HV system but I proceeded to check the other DTCs. P3120 (HV Transaxle Assembly Malfunction) (Figure 3) confirmed the DTC HV P3002, but I had to look into the sub system DTC 253 Generator Resolver Inter-Phase Short. The sub system DTC lead me to the cause of my HV problem. The MG had a shorted winding that I confirmed with my megohm meter (Figure 4 - Bad & Figure 5 - Good.)

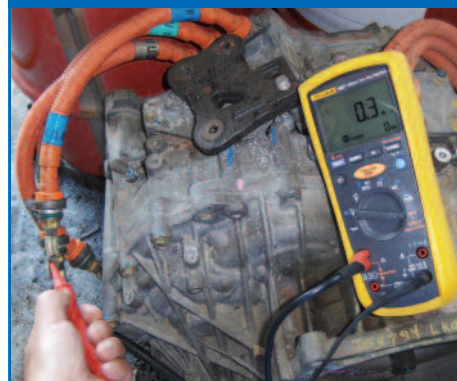
Figure 4: Hybrid transaxle with shorted MG windings

I was confident with my diagnosis and recommended replacing the salvage yard transaxle. We waited three weeks for the salvage yard to locate a replacement. When it arrived, we made sure to check the unit for visible damage and/or shorted windings. The transaxle was replaced for the second time, test driven and checked for DTCs, all without any problems. The Prius was ready to be returned to the customer, minus the Triangle of Doom. **AIRTEX**

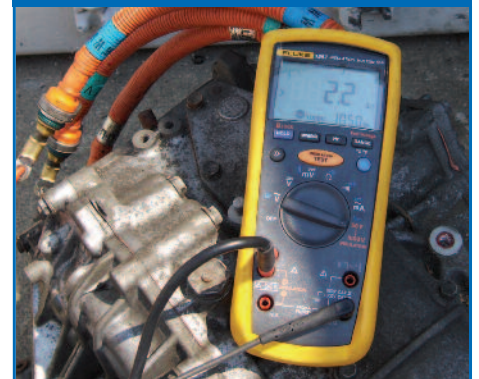
Figure 5: Second transaxle with good MG windings
