ABS Speed Sensors

This article focuses on the operation and diagnosis of the variable-reluctance ABS speed sensor.

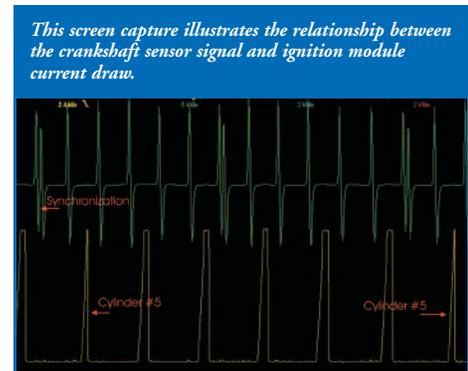
Next, we backprobed the feed wire from the crankshaft position sensor to the control module and amp clamped the battery feed wire to the ignition control module. The labscope waveforms shown in the illustration below are the results of the test. The crank sensor produced the green waveform at the top of the screen capture, and the yellow waveform at the bottom represents the amperage draw to the control module.

Question: What could cause this type of amperage draw pattern on cylinder number 5?

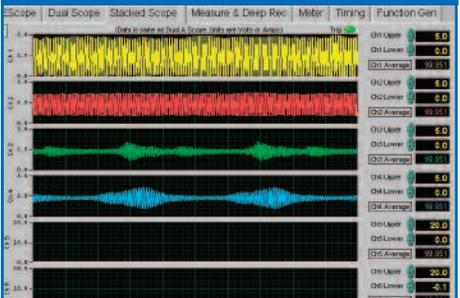
Both rear axles had been replaced on this 1998 Lincoln Town Car. The trigger wheels were approximately .060-in. smaller in diameter than OE. This can be seen on channel 3 (green) and channel 4 (blue). There were no DTCs set, however this caused a false ABS activation to occur at low speeds.

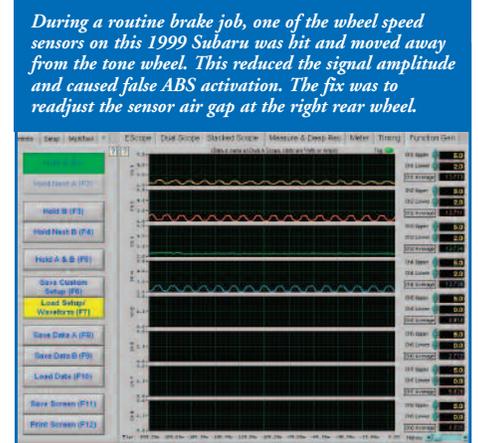
A code may not set if the sensor is producing sufficient voltage, even though there is noise present. Noise, as indicated by hash in the waveform, may cause the control unit to misinterpret the signal and cause erratic ABS operation that may not be accompanied by a trouble code. The control unit may or may not have the sophistication to identify a signal that's compromised by noise. Instead of identifying the signal problem, the control unit could see it as a wheel speed variation and activate the ABS.

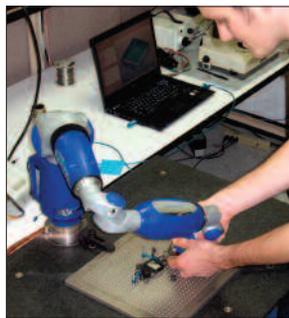
The use of integrated mobile measurement equipment allows greatly improved measurement accuracy during the part manufacturing process.

A difficult challenge in the manufacturing process is the verification of fit integrity. This is why Airtex Engine Management has integrated mobile measurement equipment into our manufacturing process. With the arm, accuracy of ± 0.000197 inches (*that's 197 millionths of an inch*) is possible. For comparison, the average human
